## **METALLURGICAL ANALYSIS IN THE OUTER TUBE FAULT AREA**

### **ABSTRACT**

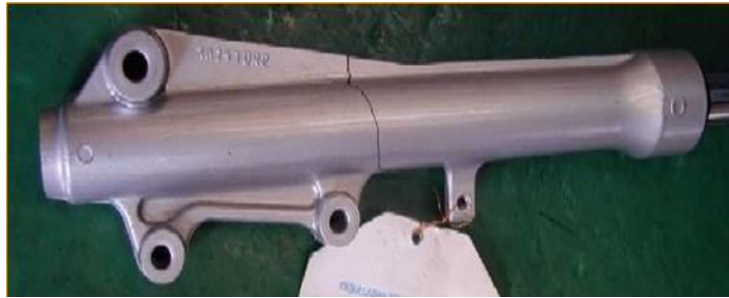
The research sample is a tube outer which is a component part of a motorcycle front fork. This outer tube component is cracked and broken before being used. A photo of this tube outer fracture can be seen on figure 1 below.

Figure 1. Crack on Tube Outer

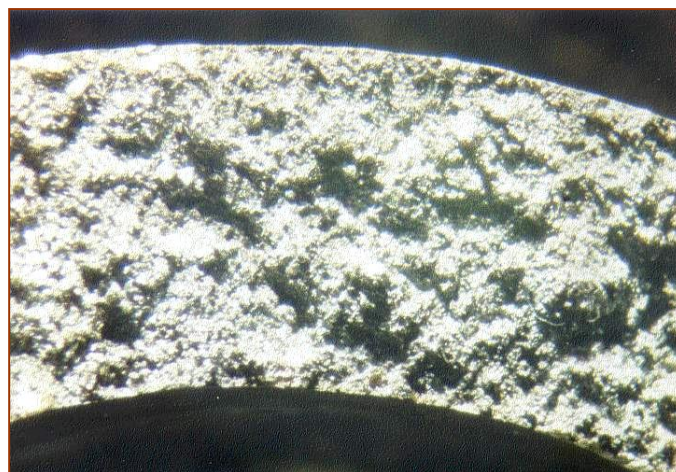
The following shows the results of the fractography test using macro photos. Based on the morphology of the fracture surface that looks like lumps (concave-bulges) in figure 2a and 2b, where there are no visible traces of plastic deformation which are generally like grooves (beachmarks).

Figure 2a. Concave-Bulges Morphology on Fracture Surface (mag. 6x)

Based on the morphology of the fracture surface from the results of the fractography test, information can be obtained where the fracture occurs in a brittle fracture mode. This was also reinforced by the fact that there were no traces of plastic deformation found on the fracture surface. Observations on the morphology (protrusions-dents) that appear characteristically indicate that there is a lot of gas trapped in the metal before fracture occurs. A collection of gases trapped in large quantities will certainly put a lot of pressure on the metal which starts when the metal freezes. The existence of many shafts in the microstructure of a metal component will reduce the micro-sectional area and contribute to a significant increase in stress when the metal component is subjected to normal loads. This condition will be coupled with the great pressure from the gas collection contained in the metal.

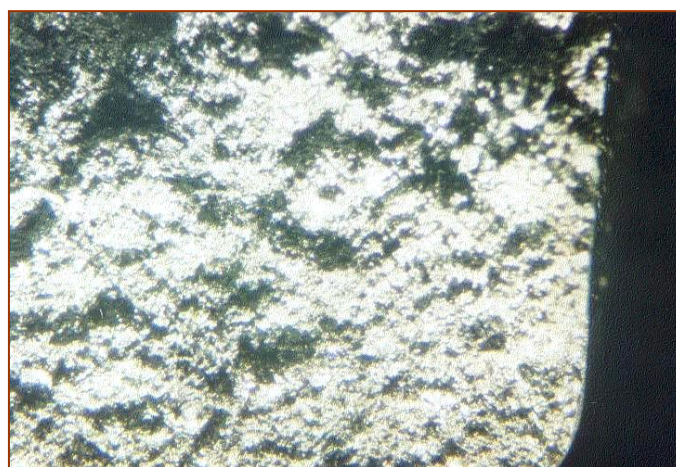
Figure 2b. Brittle Fracture Surface (mag. 6x)

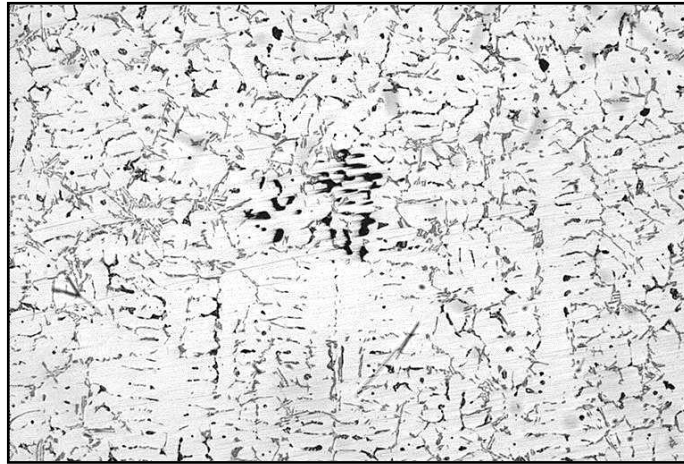
The metallographic test results can be seen in the image below with several different magnifications to be able to observe more clearly the existing microstructure. The eutectic phase appears with a dendrite structure and quite a lot of porosity and is quite large in size (figure 3a, 3b dan 3c).

Figure 3a. Outer Tube Microstructure (visible dendrite structure and porosity between the aluminum matrix, mag. 140x)

The results of the metallographic test are the data needed to strengthen the results of the fractographic test in more detail. Various facts on the observation of the fracture morphology will be consistent with the evidence shown on the microstructure. The overall microstructural conditions show a eutectic phase with a uniform dendrite structure pattern. This provides information on the entire freezing process experienced by the metal. Metal freezes quite quickly, this can be the cause of trapping a lot of gas in the metal. Besides that, from the microstructure, it can be seen that there are many porosities with quite large sizes. This can provide an indication of the relationship between the microstructural conditions and the fracture surface morphology of the component.

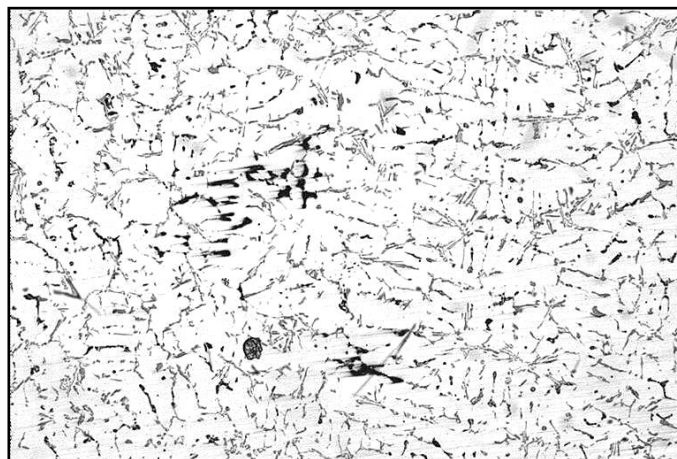
Figure 3b. Outer Tube Microstructure (visible dendrite structure and porosity between the aluminum matrix, mag. 140x)

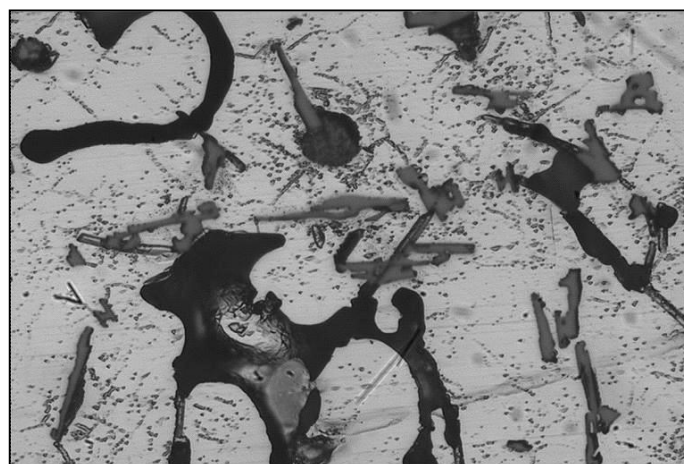
Figure 3c. Outer Tube Microstructure (visible eutectic phase and porosity between the aluminum matrix, mag. 550x)
