ANALYSIS OF BIKE REAR SHOCK BREAKER FAULTS MOTOR ON THE UNDER BRACKET

ABSTRACT

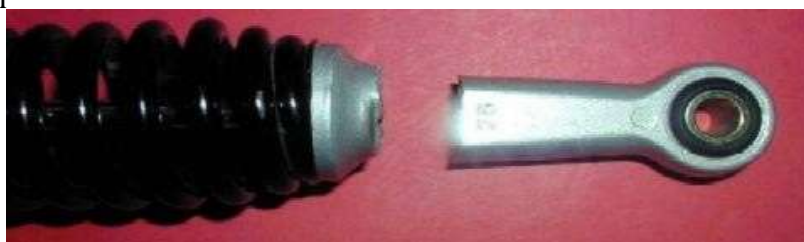
Figure 1. Shock breaker samples

Testing the shock breaker samples in this study used the fractographic test method and metallography. Sample of a broken shock breaker at the location of the connection with the piston rod. Please note that the shock breaker breaks suddenly with use normally around six months. we can see in

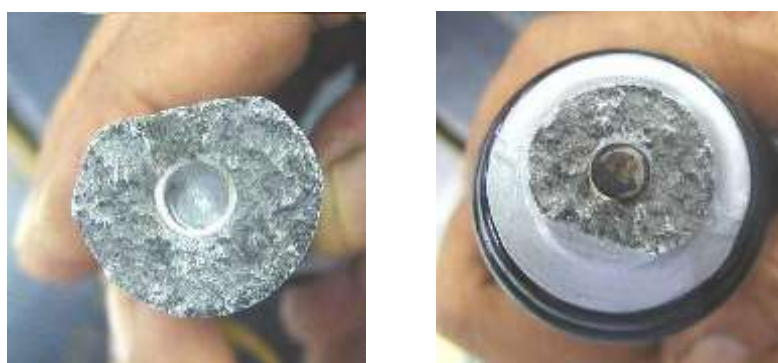
Figure 2. Lower and Upper Faults

Fractography test data collection is carried out to determine the beginning of cracks and their propagation. The results of the factography can be shown in Figure 2 and Fig 3.

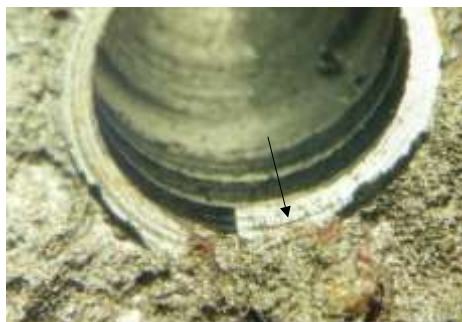
Figure 3. Enlargement on the Internal Thread

When the shock breaker fracture sample is enlarged again, the beginning of the crack propagation will begin to be seen. Can be seen more clearly in Fig. 3 and Fig 4.

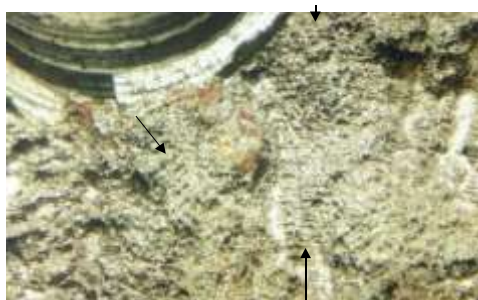
Figure 4. Enlargement at the Beginning of the Crack Propagation

From the picture above it can be seen that the crack extends from the screw head along the length of the piston rod. We can know this because after the factographic process, the crack propagation is clearly visible because the texture is different from the others. After knowing the propagation of the crack using the fractographic test above, it is continued with the metallographic test to find out the cause of the crack. Metallographic test data collection is carried out on a sample of the initial area of the crack. With a magnification of 550 times, it becomes clearer that there are air-filled porosities along the cracks in the sample body. From this we can conclude that the cause of the fracture of the sample shock breaker is this porosity

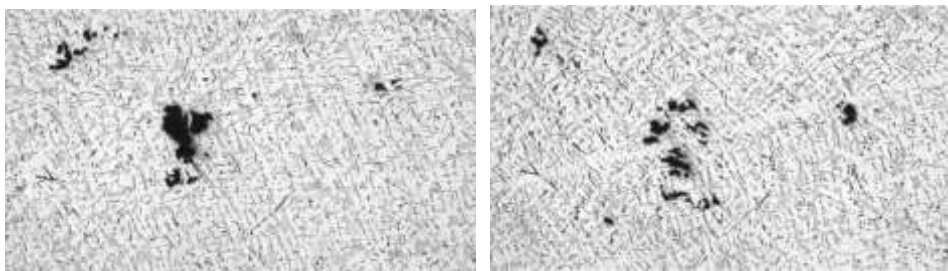
Figure 5. Under Bracket Microstructure (70 times magnification)

After the metallographic process with etching and electron microscopy with 70 times magnification, we can see the porosity along the crack propagation in the sample. After that we zoom in again with a magnification of 550 times it will look like in Figure 6 as follows.

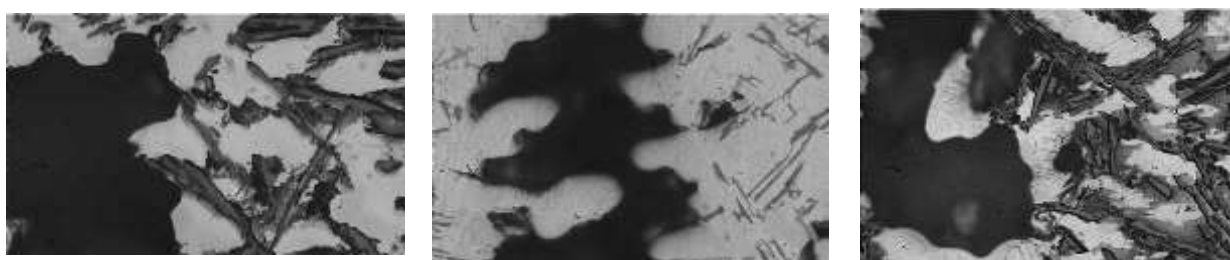
Figure 6. Under Bracket Microstructure (550 times magnification)

which makes the structure of the shock breaker weak in that part which eventually cracks, propagates and finally breaks.
